Existence and the Spatial Memory of Gaza: The Case of Al-Alami Historical House

Abdurrahman Mohamed

Faculty of Engineering

Antalya Bilim University, Antalya, Turkiye

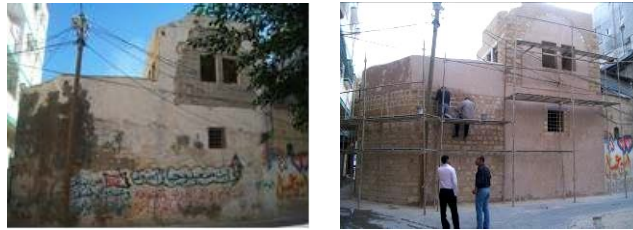
Figure 14: South façade before (left) and after (right) restoration.

The southern and western facades of the building overlook the adjacent alleys and are in good structural condition. The cement plaster was meticulously removed, the natural stone was then cleaned and treated with grout, and the stone courses were then pointed (Figure 14).
